BUILDING EVALUATION AND RESERVE FUND STUDY

BELMONT PARK 8400 ARIEL STREET HOUSTON, TEXAS 77074

November 8, 2004

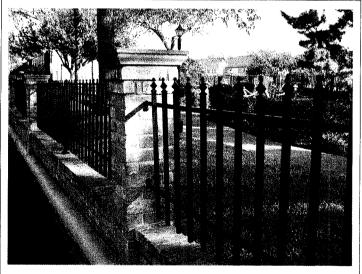
The brick and wrought iron fence at the pond and in front of the playground has several columns that are leaning and many cracks in the brick. We recommend major repairs or replacement of this fence in the short term.

Previously Repaired Brick Column

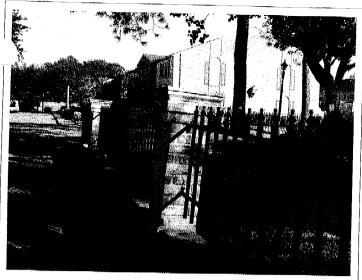
Three Columns Leaning Back

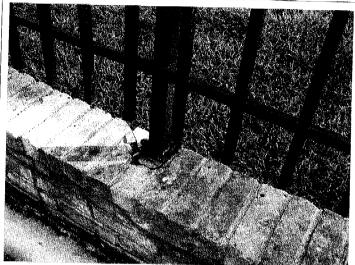
Broken Steel Post Between Two Leaning Columns

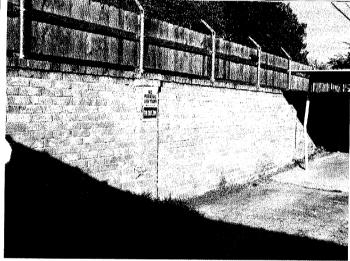
The brick wall on the left side of the property contains many step cracks that need to be addressed in the short term. Also, a small wood fence was added on top of the wall as it was not tall enough to provide privacy between Belmont Park and the neighboring property. Many sections of the wall have already been replaced with a stockade type wood fence. We recommend replacing the brick wall with more of the wood fence instead of making repairs to the wall.

Brick Fence at Left Side of Property Bent Column @ Carport

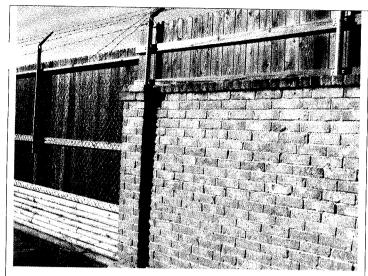
Brick Wall and Replacement Fence

with a stockade type wood fence. There is a proposal for replacing the brick fence that remains with wood fence, rather than repairing the brick.

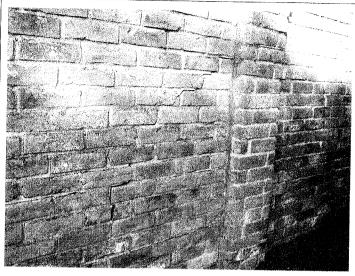
Step Crack, Typical Every 50'

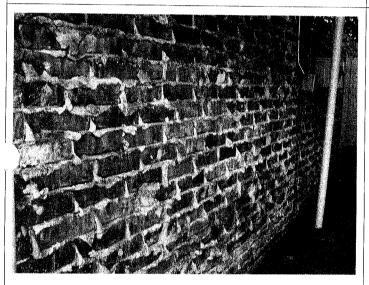
Un-struck Mortar Wall Cladding

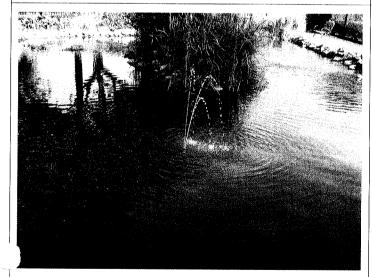
Fountains-Weak Flow

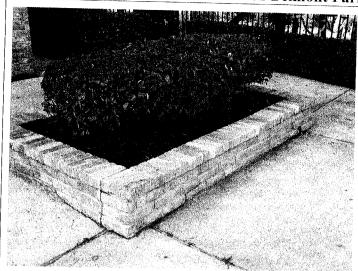
The brick planter boxes at the swimming pool are cracked and displaced in several places. We have included funds for repairs in year one.

Planters Around Pool (Brick Damage)

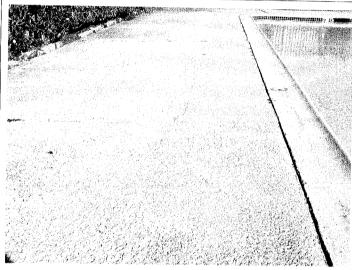
Deck Patching - Grouting

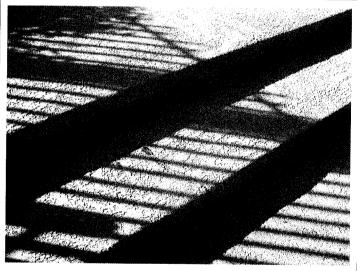
Cracking Issues at Baby Pool

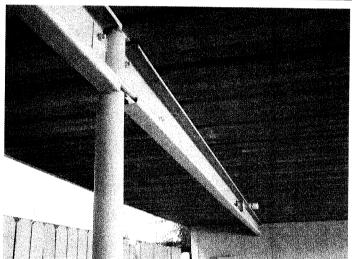
The carport roofs are in fair condition. These roofs have been repaired in many locations. A major repair or replacement is to be expected some time in the next twenty years.

Steel Frame- Galvanized Roof

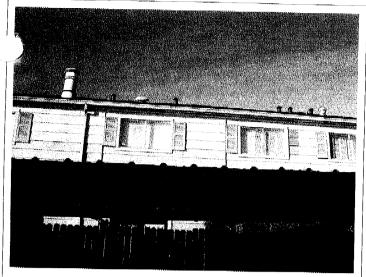
Reportedly, over the last two to three years many of the buildings have had major repairs to the exterior siding. Currently, all but six of the buildings have recently had deteriorated siding removed and replaced. We have included funds to complete these repairs over the next three years. It was observed that the buildings have little to no eave which makes it extremely important to maintain the siding and keep the gutters functioning properly. We recommend painting and waterproofing these exteriors on a five year cycle. This would include the replacement of all exterior caulking at window perimeters, brick expansion joints and dissimilar materials. Also, another major repair should be expected some time in the next twenty years.

Unit # 8315 Siding in Poor Condition

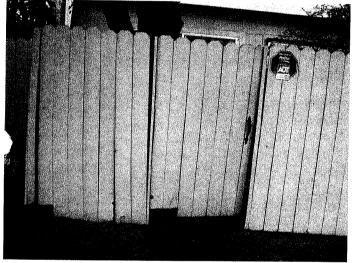
Damaged Privacy Fence at #1852

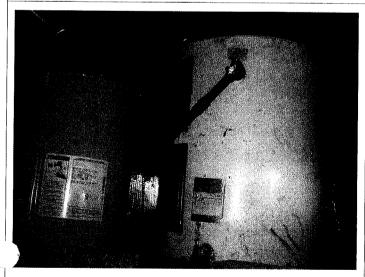
Operational Water Heater on Left, Abandoned Water Heater on Right
