**CONCRETE EVALUATION AND
RESERVE FUND STUDY**

***BELMONT PARK
8400 ARIEL STREET
HOUSTON, TEXAS 77074***

APRIL 1, 2004

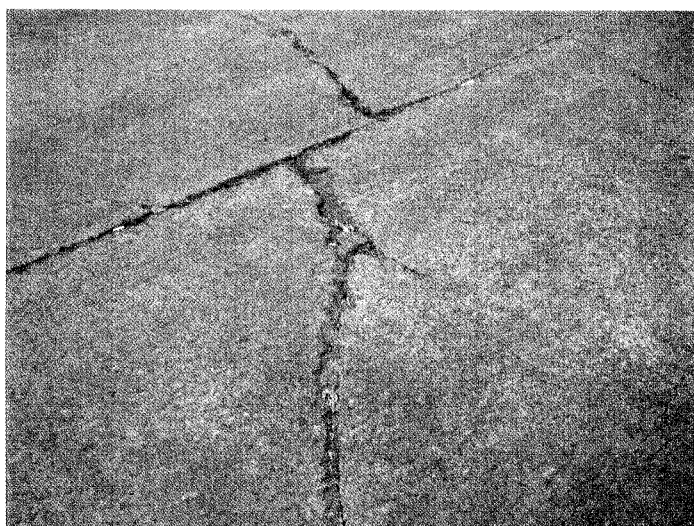
Wide Crack

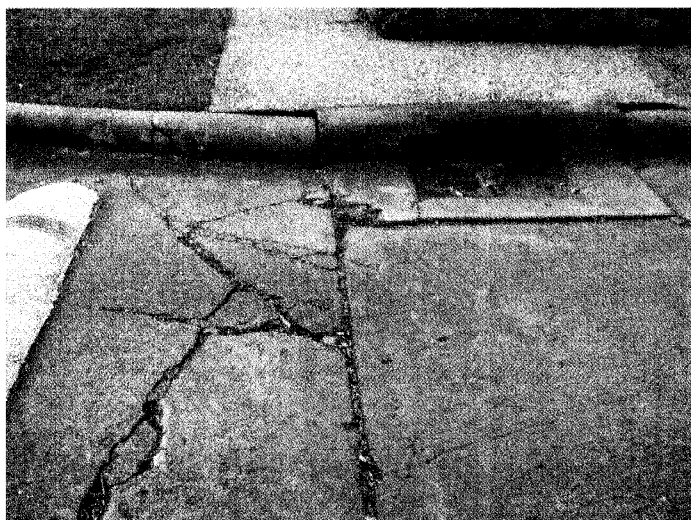
Cracks/Settlement @ Bldg. 8

Because of present conditions, the following are high priority items that will need your immediate attention. We recommend full depth repair of a 24' by 48' section of concrete pavement South of building 8 in the first year. This

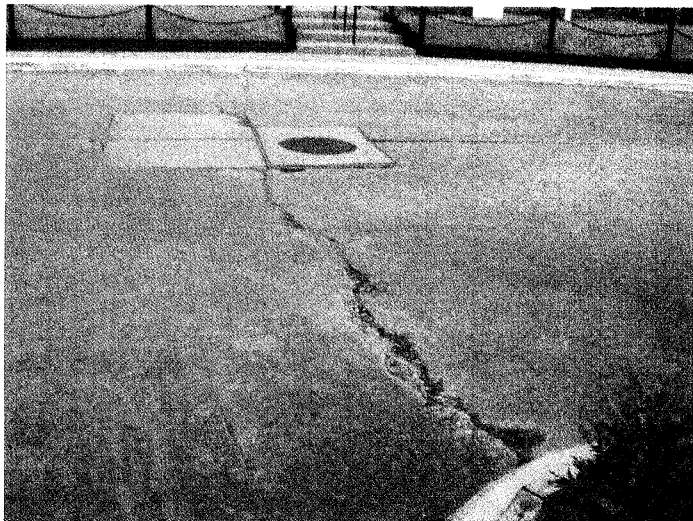
2" Displacement

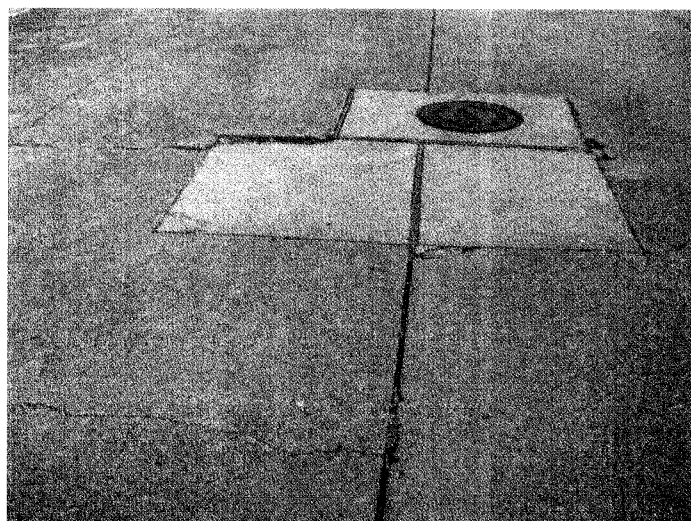
Excessive settlement of patch

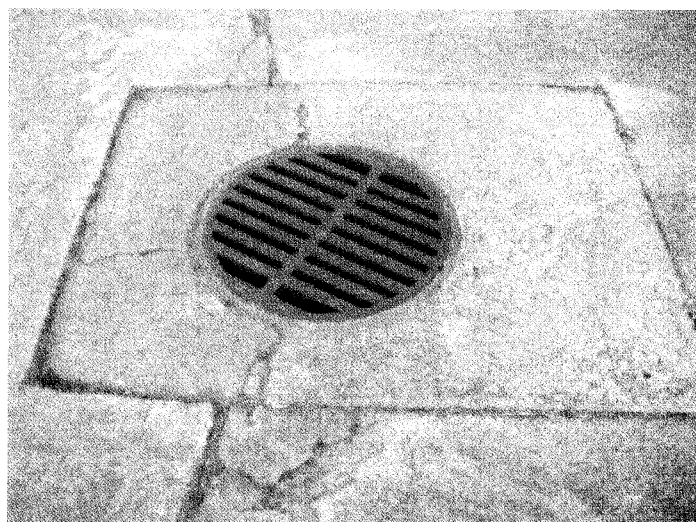
Settlement/Cracking @ Storm Drain

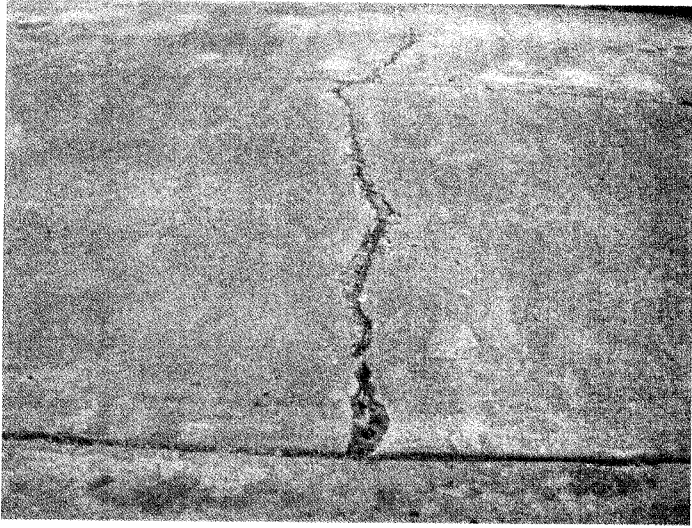
Crack in Pavement

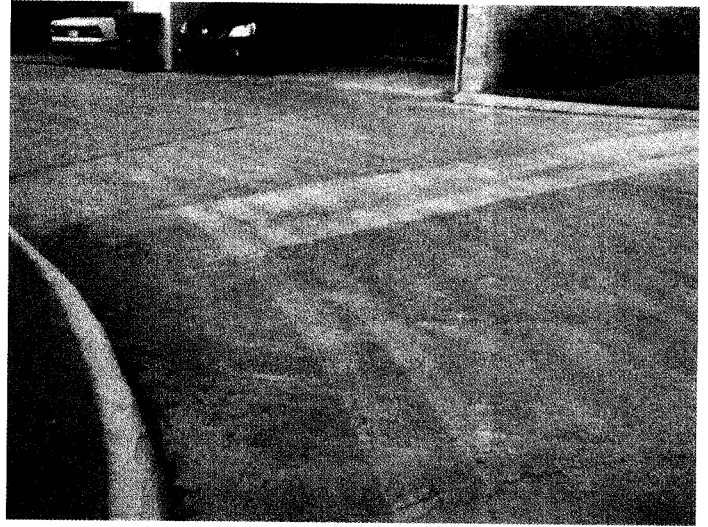
Poor Drainage Bldg. 9 & 10

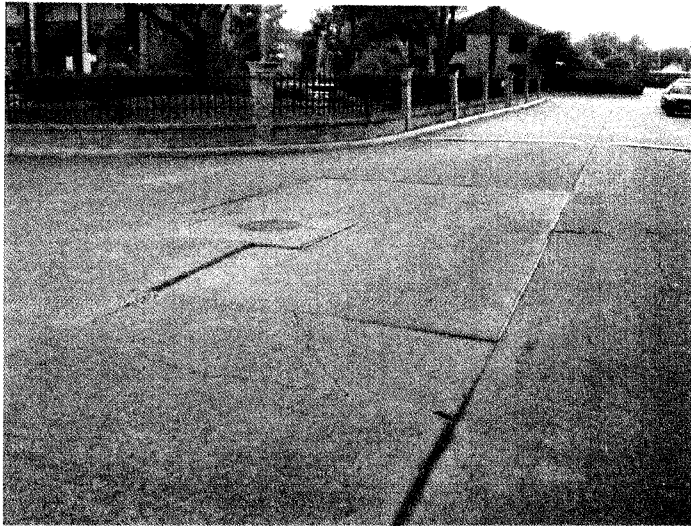
Settlement South of Building 8

patch should be properly doveled into surrounding pavement for load transfer. Similar patches of this magnitude should be expected throughout the complex about every five years. A catch basin should be installed by unit 8482 to divert water to existing underground piping. Breaks in the concrete pavement with displacement greater than 1 inch should be planed or diamond ground to improve rideability. Trip & fall hazards should be addressed in a similar manner. All cracks greater in width than a 1/4" should be properly routed and filled with an oil resistant sealant. Sealant should be replaced on a five-year cycle beginning in the first year. The concrete curbing is in relatively good condition at present. There are some areas of cracking and deterioration. We have anticipated various concrete repairs to the curbing to occur on a five-year cycle beginning in year one.

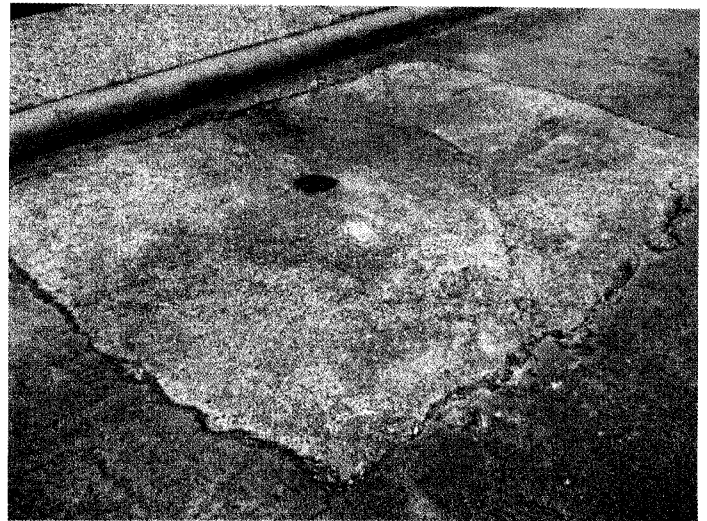
Rough Finish on Repair

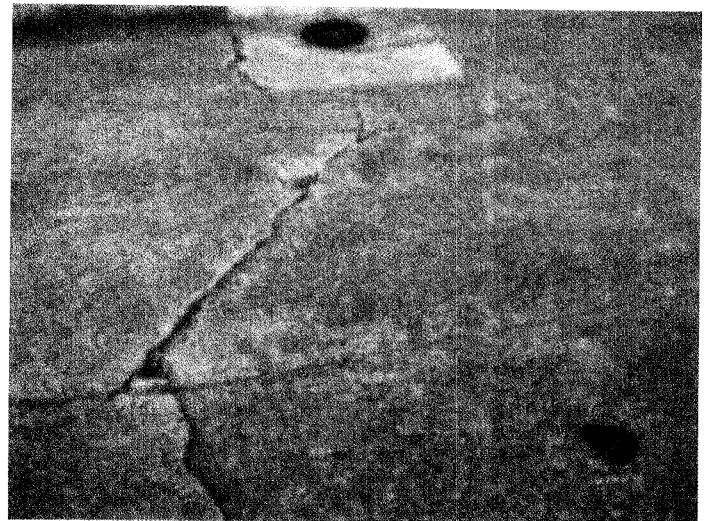
Settlement/Cracking Around Storm Drain

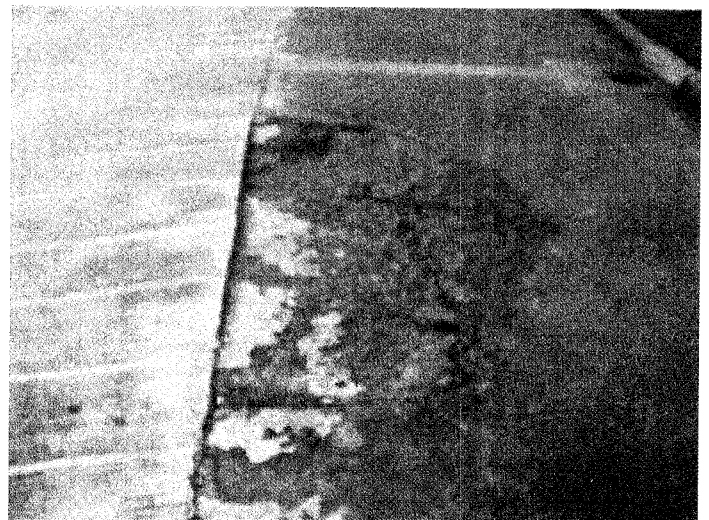
Rough Surface on Pavement

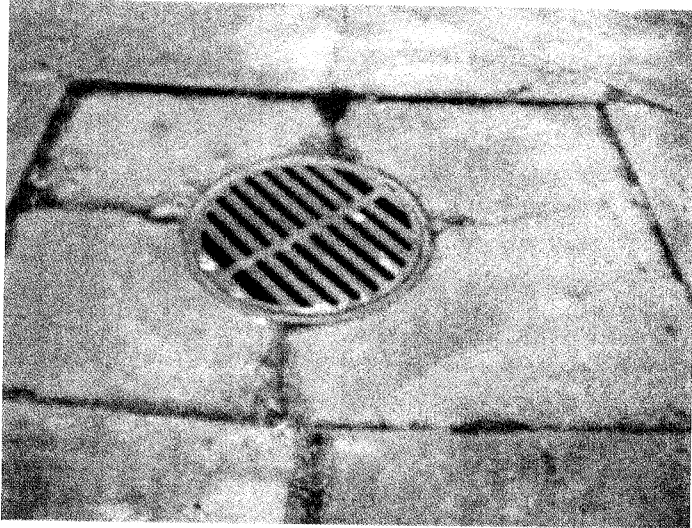
Cracking Around Storm Drain

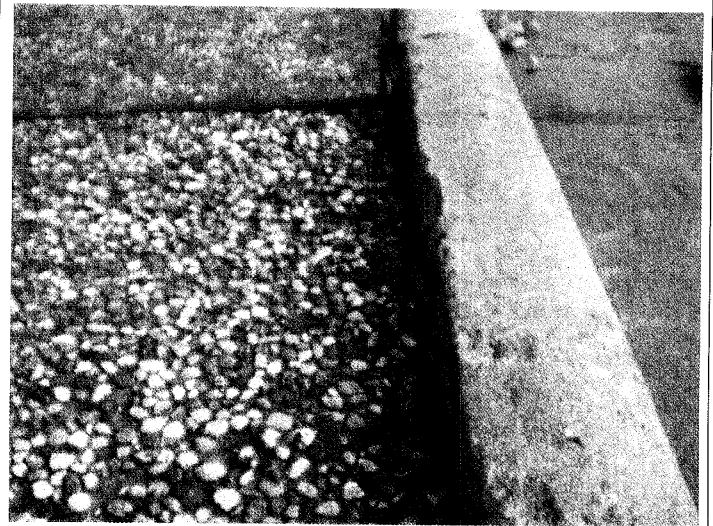
Sidewalk Settling @ Curb

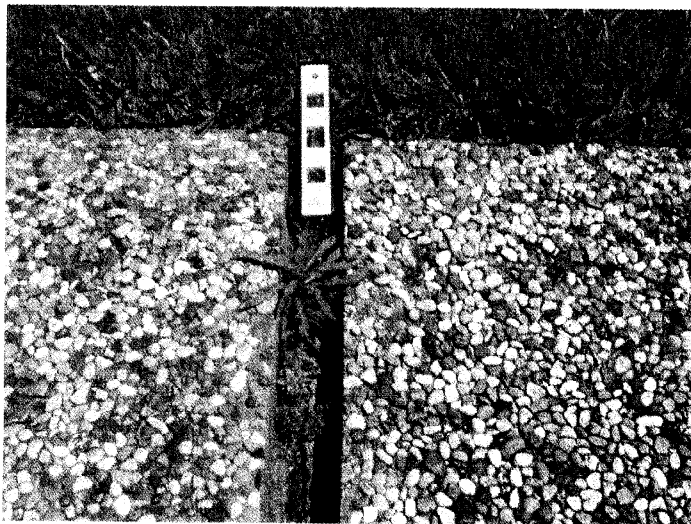
Missing Joint Filler

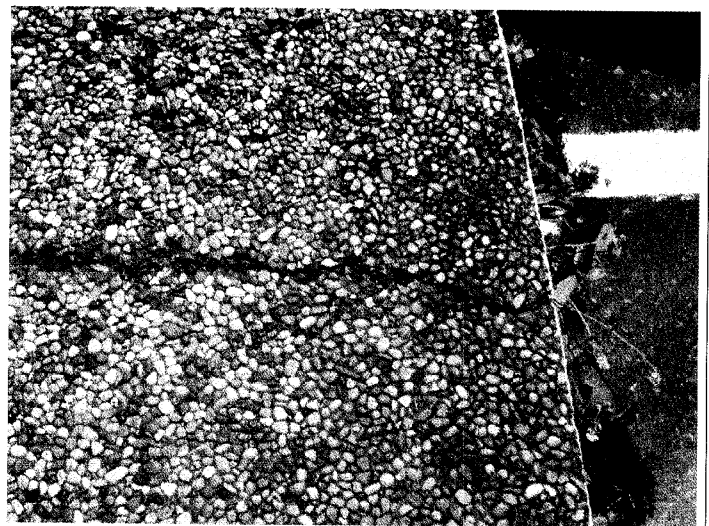
Crack in Sidewalk

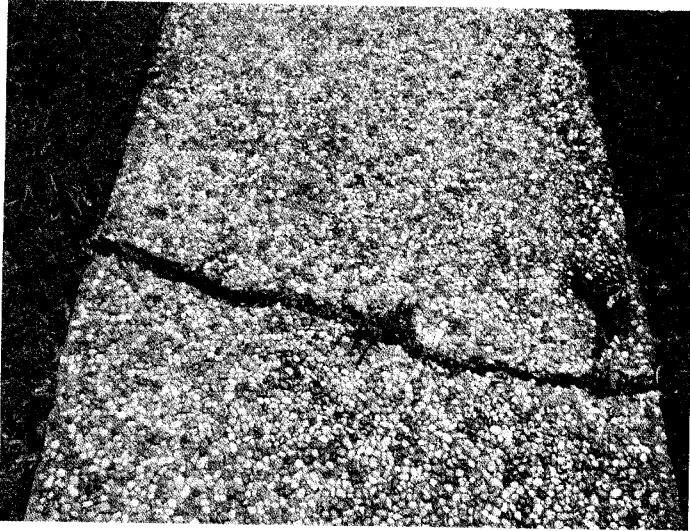
Displacement – Trip and Fall

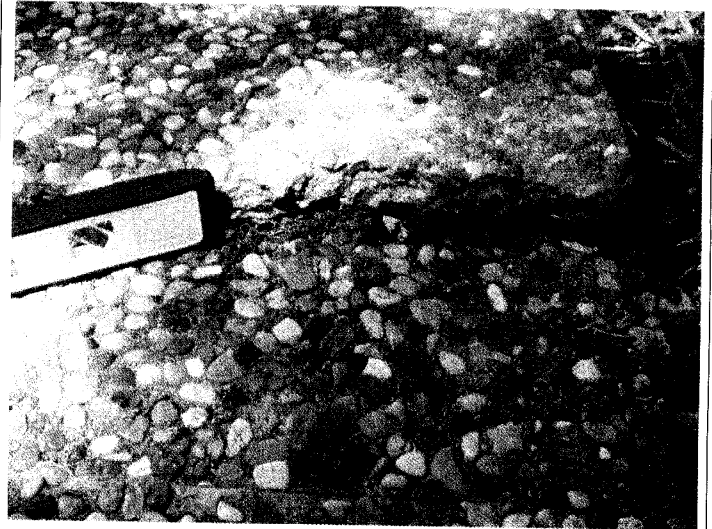
Displacement – Trip and Fall

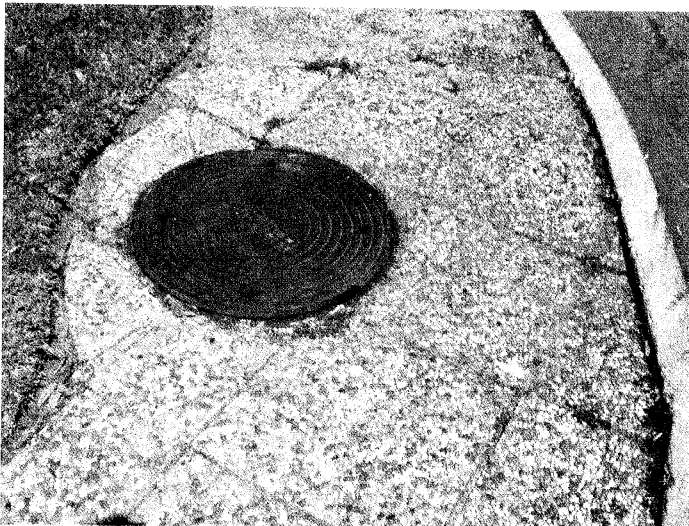
Uneven Pavers

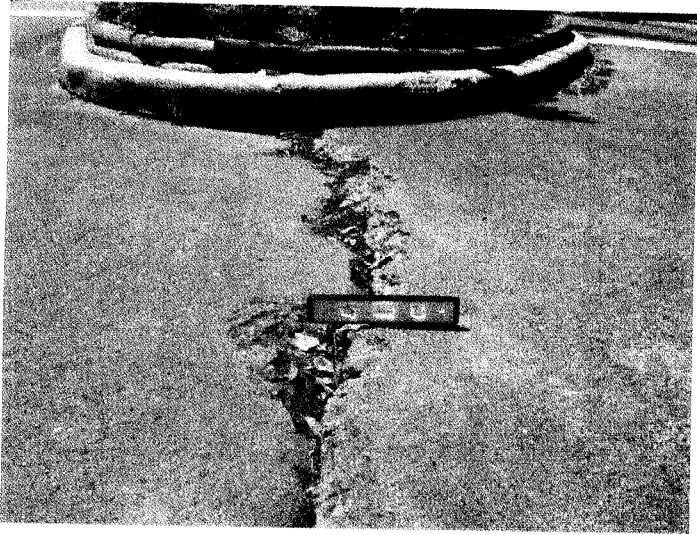
Concrete Break and Displacement

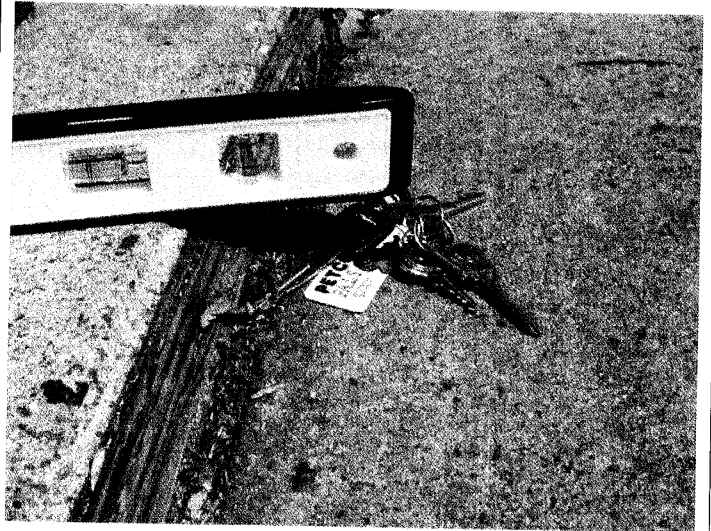
Displacement over Joint

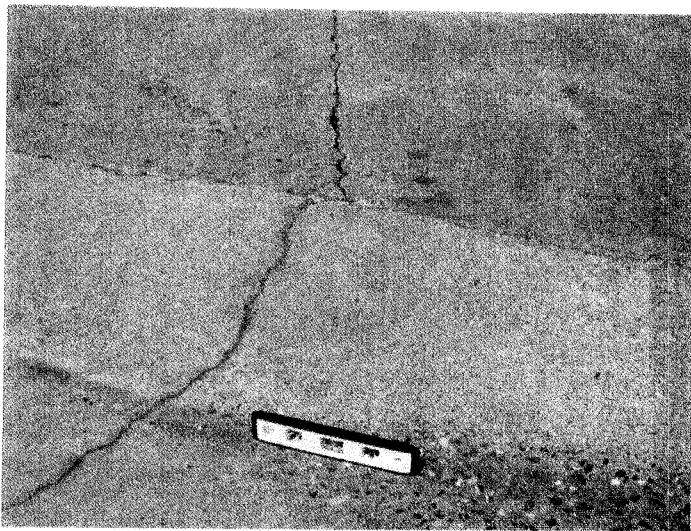
Drainage Trough at Unit 8482 – negative slope

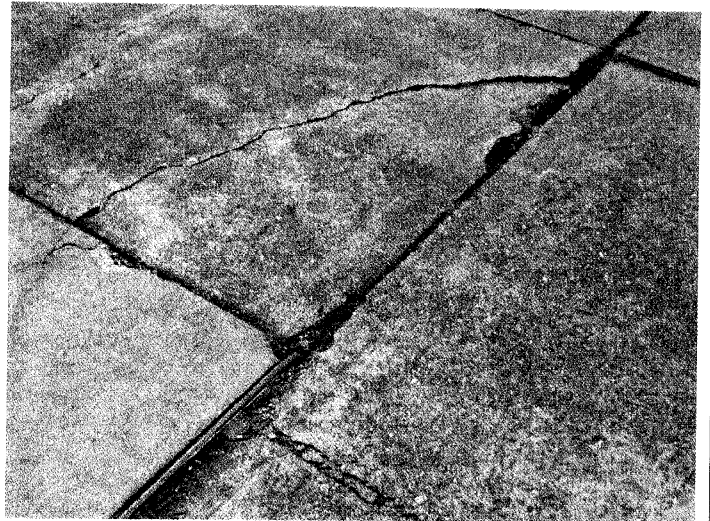
Cracking around Patch
